Towards Understanding Tribocorrosion in Hip Replacements

Emily Hoffman, Yifeng Liao, and Laurence D. Marks

Department of Materials Science and Engineering, Northwestern University, Evanston, IL

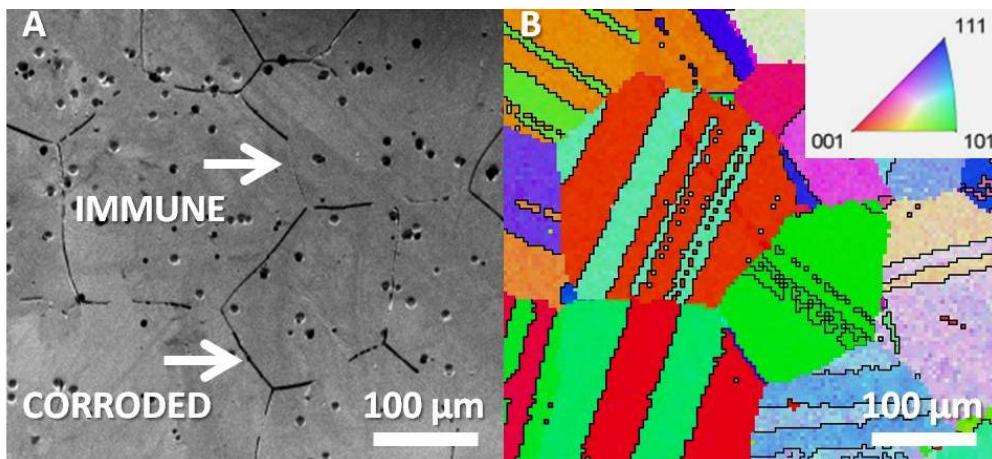
The misorientation of the grain boundaries was determined through electron backscattered diffraction (EBSD) and was quantified using coincident site lattice geometries ($\Sigma_3 - \Sigma_{35}$) using the tolerance as defined by the Brandon Criterion, $\Delta\theta \leq 15^\circ(\Sigma^{-1/2})$ [2]. An SEM in Figure 1 (A) shows the visual difference between corroded and immune grain boundaries, while (B) shows the EBSD mapped crystallographic orientations. Previous work on the crystallographic misorientation for 102 corroded and immune grain boundaries showed that 100% low-energy grain boundaries did not corrode, whereas only 30.4% of general high-angle grain boundaries did not corrode [3]. This indicates that the crystallographic orientation affects corrosion susceptibility in CoCrMo. Using this knowledge of grain boundary orientation, focused ion beam (FIB) was used to make TEM samples of specifically selected, high-energy grain boundaries to evaluate the composition across the boundary.

Figure 1. (A) A SEM image showing the corroded and immune grain boundaries in a CoCrMo sample, along with the EBSD crystallographic mapping to determine the grain boundary energy in (B).

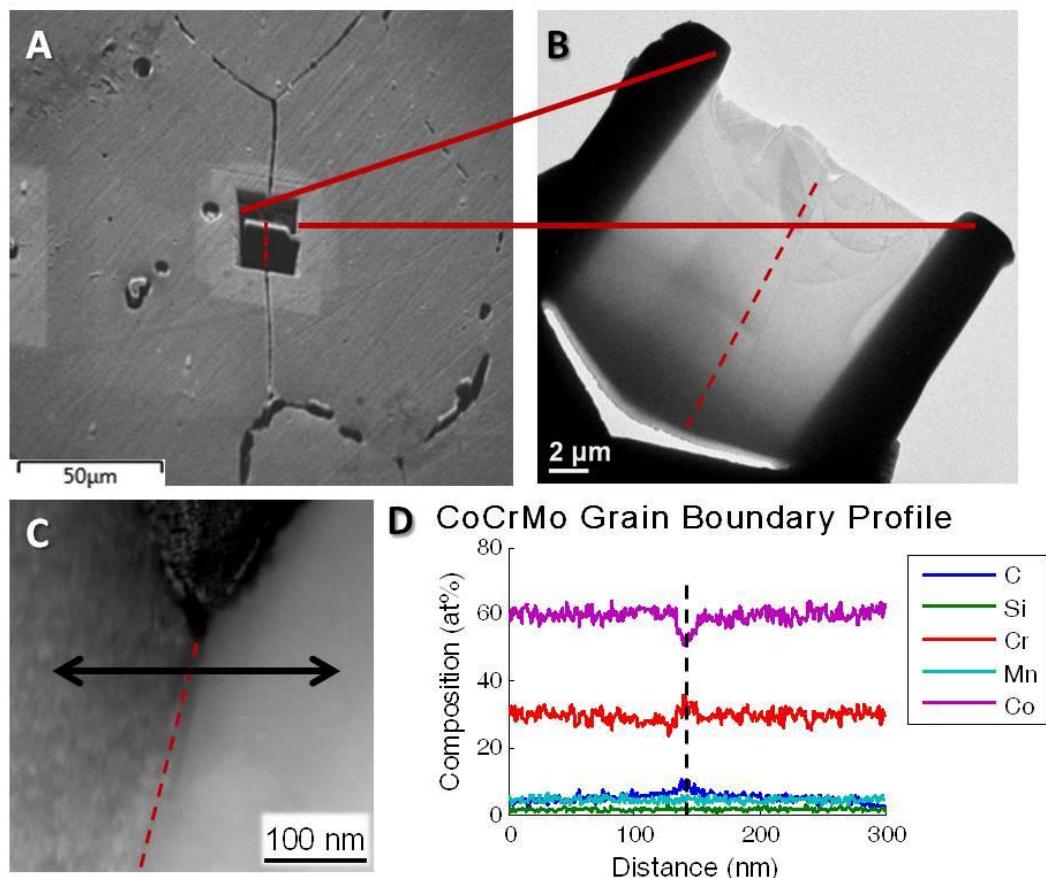
EDS was employed to scan line profiles across the high-energy grain boundaries of the CoCrMo TEM samples. Figure 2 (A) and (B) show an example TEM sample FIB'ed from a corroded grain boundary. Figure 2 (C) shows the EDS scan area, with (D) depicting the alloy element compositions across the scan. EDS results indicate that, at the corroded boundary, there is a depletion of cobalt and an enrichment of both carbon and chromium around approximately 10 nm on either side of the boundary. This trend of Co depletion and Cr enhancement is seen in three out of four samples initially evaluated, to various degrees. Our preliminary results showed composition along the depth of the grain boundary changes, necessitating further TEM analysis to determine the segregation levels and atomic structure of corrosion susceptible grain boundaries.

Figure 2. (A) FIB/SEM image showing a single grain boundary being cut from the sample, viewed in a TEM in (B) and (C) and EDS spectra indicating Co depletion (purple) and Cr increase (red) near the boundary marked with the dashed line in (D).
